Perge 2006

Haluk ABBASOĞLU

The excavation and repair work at Perge in 2006 was conducted from the 25th of July to the 9th of October by the Centre for Archaeological Research in Antalya Region of İstanbul University's faculty of Letters, with the permission issued by the Directorate General of Museums and Cultural Heritage. Our excavation was financed by the Directorate General of Museums and Cultural Heritage of the Ministry of Culture and Tourism, as well as by DÖSİMM, by the Administrative Secretariat of Scientific Research of İstanbul University, by the Suna & İnan Kıraç Research Institute on Mediterranean Civilizations (AKMED) and the Cultural Awareness Foundation. The Turkish Historical Foundation also made a symbolic contribution. We would like to express our appreciation to all these institutions for their support.

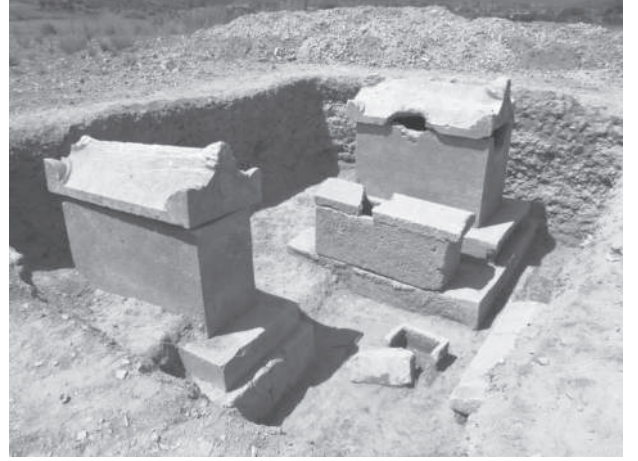
Res. 1 Batı Nekropolis, Parsel 159 çalışma alanı

Fig. 1 Western necropolis, the work area in lot 159

Batı Nekropolis'te kazılan ikinci alanda, 2006 yılında kapakları kısmen yüzeyde olan iki lahitte kaçak kazı yapıldığı tespit edilmiş ve bunun üzerine burada çalışmalara başlanmıştır. Söz konusu lahit (L60), yerel kireçtaşından yapılmış olup, kapağının doğu alınlığında yarı plastik bir Medusa kabartması vardır ve bezemesiz teknelidir. Stilize arslan ayaklı bir kaide üzerine oturtulmuştur. Bu lahdin güneyinde kireçtaşından, alınlıkları kalkan kabartmalı, akroterli beşik çatılı kapağa sahip, doğu kısa kenarında 6 satırlık bir Eski Yunanca yazıt bulunan bezemesiz tekneli bir lahit (L61) ortaya çıkarılmıştır. Bu lahitten 1 altın küpe, 2 cam boncuk ve 1 bronz obje ele geçmiştir. Bu iki lahit arasında ise, L60 ile aynı kaide üzerinde, kireçtaşından, beşik çatılı bir kapak ve bezemesiz bir tekneye sahip, bir lahit daha bulunmuştur (L62). Bunların doğusunda kuzey-güney doğrultulu bir başka lahit (L63) yer almakta olup, dikdörtgen formlu bezemesiz bir tekneye ve alçak beşik çatılı bir kapağa sahiptir. Daha önce hiç açılmamış olduğu anlaşılan lahdin içinde 5 bireye ait iskeletler eksiksiz ve *in situ* ele geçmiş, mezar hediyesi olarak da bronz sikkeler, cam ve pişmiş toprak unguentariumlar, bronz aynalar, kemik maryonet, bronz yüzük ve aplik, demir strigilis ve bronz kandil süsü bulunmuştur. L63'ün doğusunda yapılan çalışmalarda, daha önce hiç açılmamış 3 lahde rastlanmıştır (L67, L68, L69). Dikdörtgen formlu tekneye ve alçak beşik çatılı kapağa sahip olan bu lahitlerde *in situ* iskeletler ve çok zengin olmayan çeşitli mezar hediyeleri ortaya çıkartılmıştır. 2006 yılı çalışmalarının en sonunda, L68'in doğusunda bulunan bezemesiz tekneli, kireçtaşından lahit (L70), zengin bezemeli kapağı ile diğerlerinden ayrılmaktadır. Kapağın batı alınlığında kalkan, doğu alınlığında da yarı plastik Medusa başı kabartması vardır. Tüm bu lahitlerin dışında, biri L62'nin güneyi, diğeri ise L63'ün güneyinde olmak üzere, kireçtaşından beşik çatılı ve teknelerinin kısa kenarları kapı bezemeli 2 adet ostotheke (Os.1 ve Os.2) bulunmuştur. Bu ostotheke Perge'de bulunan ilk *in situ* örneklerdir (Res. 1).

with an undecorated lower section, to the east of L68, with a very richly decorated lid was found. On the east pediment of its lid is carved a relief of a Medusa head and there is a shield in the west pediment. In addition to all these sarcophagi, two limestone ostotheks (Os.1 and Os.2) were found – one to the south of L62, the other to the south of L63; both having pitched roof-type lids, and door decoration on the short sides of their lower sections. These ostotheks are first in situ examples found from Perge (Fig. 1).

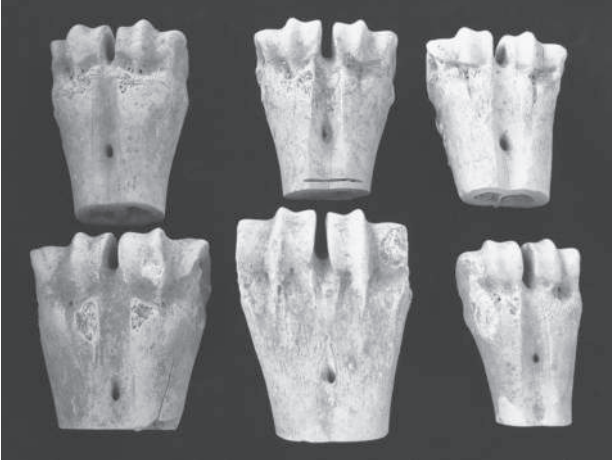
Res. 2 Parsel 159 kazısında bulunmuş düzgün kesilmiş kemikler
Fig. 2 The purposefully cut bones uncovered in lot 159

bulunan damgalı amphora kulplarındaki, Latince ve Eski Yunanca atölye-usta isimleri, tarihleme, ticaret ve atölyeler konusunda önemli sonuçlara ulaştıracaktır. Çok sayıdaki keramik parçalarının yanı sıra, eklem yerlerinden düzgün kesilmiş büyük baş hayvan kemiklerinin de çok sayıda bulunması, Perge'de bir kemik işliğı varlığına işaret etmektedir (Res. 2). Böylece bu alanın, bir kemik işliğı ve keramik atölyesi çöplüğü olarak da kullanılmış olabileceği düşünülmektedir.

In this excavated area a baked clay pipeline extending in a north-south direction was found, which should be related to the ancient waterway to the north of the lot. Also in this area containing simple sarcophagi carved from local stone, we have uncovered many bone and pottery fragments which are fine cut. Most of these pottery pieces are of high quality Sagalassos ware produced in the 2nd and 3rd centuries A.D. In addition, the workshop and master names recorded in ancient Greek and in the Latin stamps on the amphora handles will provide us with important results in respect to dating, commerce and workshops. In addition to the large number of ceramic pieces, large numbers of deliberately cut animal bones were also found, indicating the existence of a workshop working bone at Perge (Fig. 2). This area could have been used as a bone workshop and employed as a dump area for a pottery workshop.

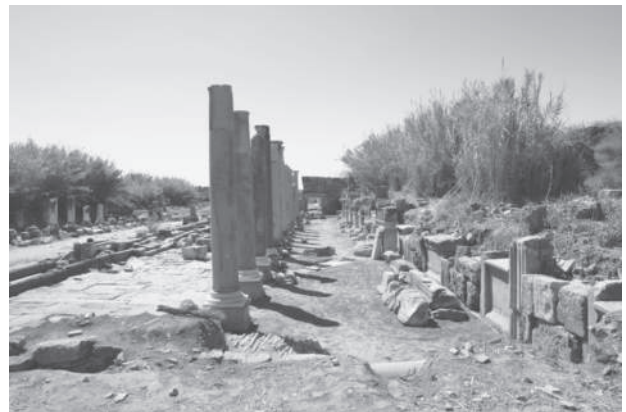
Res. 3 Sütunlu Cadde, kuzey açma

Fig. 3 The Colonnaded street, the north trench

Kuzey açmada ise, kavşak güneyinde ve sütunlu caddenin genişletilmiş bölümünde yer alan J10 sokağı kuzeyinde çalışılmıştır. 8., 9. ve 10. dükkan girişlerinin doğusunda kalan galeri ve cadde bölümleri tamamen kazılarak temizlenmiştir. Kentin ana caddesinin ortasından geçen Roma Dönemi su kanalı üzerine geç dönemde inşa edilmiş küçük kilise ile kazılan alan arasında, devşirme malzemeden özensiz biçimde örülmüş bir duvar ve Bizans Dönemi'ne ait bir adet sandık mezar ortaya çıkarılmıştır (Res. 3).

In the north trench, work was conducted to the south of the junction and to the north of street J10, located in the widened part of the Colonnaded street. The part of the gallery and the street to the east of the entranceways of the 8th, 9th and 10th shops were entirely excavated and cleaned. Between the small Byzantine church built on top of the Roman water canal in the middle of the main street and the area under excavation, a wall carelessly built with spolia and a cist-type Byzantine tomb were uncovered (Fig. 3).

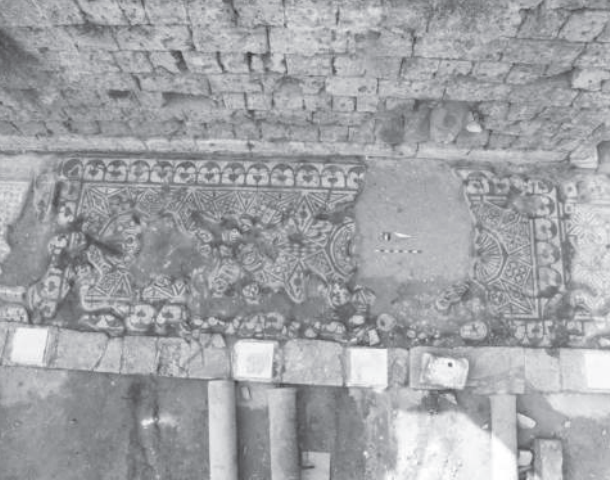
Res. 5 Güney Hamam palaestrası batı portik mozaiklerinin onarım sonrası durumu

Fig. 5 The South baths, the west portico mosaics of the palaestra following the repair work

Merkezi Paris'te bulunan AIEMA'nın (Association internationale pour l'étude de la mosaïque antique) önderliğinde hazırlanan mozaik corpusu çerçevesinde, Perge'de kent içindeki mozaiklerin belgelenmesi, onarım ve korunmasına yönelik, 2004 yılında Vehbi Koç Vakfı Suna – İnan Kırac Akdeniz Medeniyetleri Araştırma Enstitüsü'nün (AKMED) desteğiyle agorada başlattığımız çalışmalar 2006 yılında Güney Hamam ve Güney Bazilika portiğinde yoğunlaşmıştır (Res. 4). Güney Hamamın apodyteriumu, palaestranın kuzey, batı ve doğusundaki mozaikleri ile frigidariumun *opus sectile* döşemesi tekrar açılarak, bunların günümüz yöntemleriyle sistematik olarak belgelenmesi, total station ile ölçüm, fotoğraflama işlemleri yapılmış ve mimari içindeki yerleri bire bir incelenmiştir. Onarım kapsamında, mozaiklerin su, fırça ve dişçi aletleri ile mekanik temizliği yapılmış, tesseralar arasındaki toprak ve bitki kökleri temizlenmiş, korunagelmüş kısımların kenarları hazırlanan özel bir harçla sabitlenmiş ve yeri tespit edilebilen tesseralar yerine oturtulmuştur. Belgeleme işlemi tamamlanan mozaiklerin üzeri jeotekstil ve yıkanmış, tuzsuz ince nehir kumu ile örtülmüştür (Res. 5).

mosaics were mechanically cleaned with water, brush and dentistry tools; the soil and plant roots between the tesserae were cleaned; the edges of the surviving parts were fixed with a special mortar; and those tesserae whose places could be identified were re-placed. When the documentation work was completed the mosaics were then covered with geotextile and with washed fine river sand (Fig. 5).
