Rhodiapolis Kazılarında İlk Yıl: 2006

Excavations at Rhodiapolis in 2006: The First Campaign

Nevzat ÇEVİK – İsa KIZGUT – Süleyman BULUT

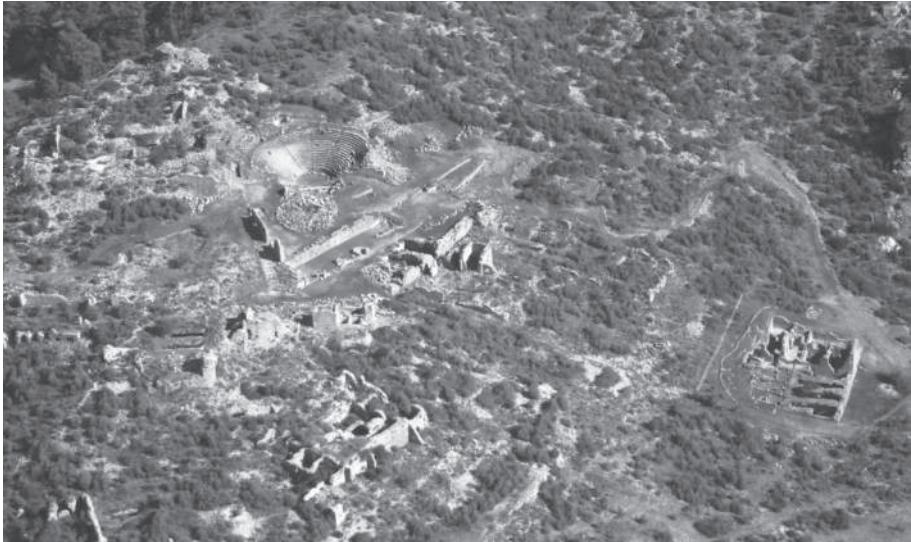
Res. 1 Rhodiapolis 2006 kazıları sonrası. Hava fotoğrafı

Fig. 1 Aerial view of Rhodiapolis after excavations in 2006

Located within the border of the Sarıcasu Köyü, in the township of Kumluca of Antalya İli, Rhodiapolis received its name from the Rhodians that colonised it. We learn of its name from Hekataios. Theopompos claimed it was named after Rhodos, the daughter of Mopsos. However, its name in Lycian is thought to have been Wedrei (Wedrennehi/Wedrenni). The name Wedrei is found together with that of Trbenni on the Dynastic period coins of Lycia. This suggests that there existed a settlement here prior to the Rhodian colonisation. The earliest ruins in this city known to have been a member of the Lycian League are the rock cut tombs dating to the Classical period. Most of the visible ruins date from the Roman and Byzantine periods. The most important remains in the city are the theatre, bathhouse, agora/stoa, sebasteion, temples, church, cisterns, cenotaph, necropolises and houses (Fig. 1, and prior to excavations see Fig. 2).

Works Conducted: The first campaign covered the following areas: an overall cleaning of the surface and vegetation in the city; the construction of vehicle roads in the city; infrastructure works; preliminary surveys for identification purposes; topographic work and excavations. The excavations were carried out in the bathhouse, agora/stoa, theatre and street (For the condition before and after the excavations see Figs. 1 and 2).

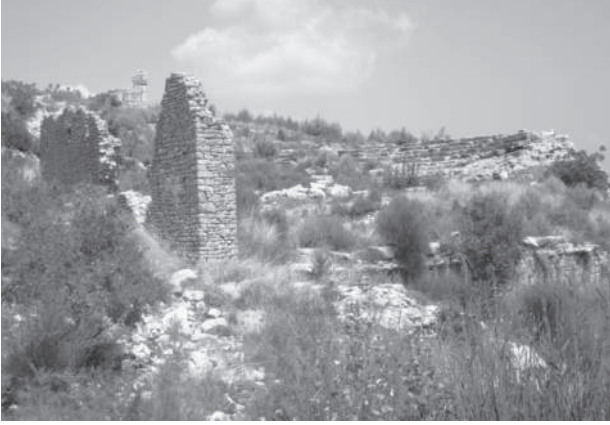
Res. 2 Rhodiapolis. Kazı öncesi kent merkezinin görünümü
Fig. 2 View of the centre of Rhodiapolis before the excavations

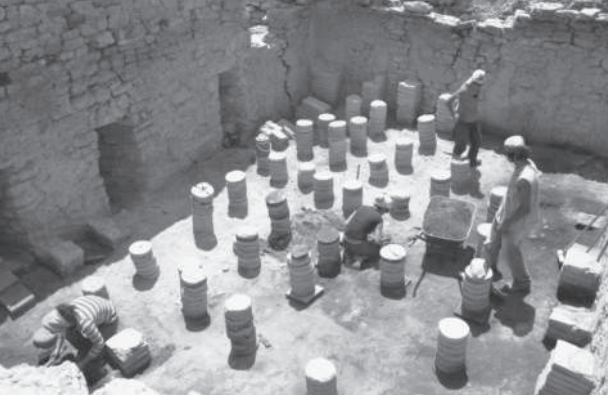
Res. 4 Rhodiapolis. Hamam tepidarium çalışmaları

Fig. 4 Rhodiapolis. Work in the tepidarium of the Bathhouse

Hamam (Res. 4): 4 ayrı alt ekip tarafından yürütülen hamam çalışmalarında kaldarium, tepidarium, frigidarium, servis ve vestibulum bölümlerinde kazılar tamamlanmış, 4 büyük sarnıca oturan palaestra bölümü kısmen 2007'ye kalmıştır. Yapıda, bir Roma hamamından beklenen tüm mimari ve iç mimari unsurlara ilişkin tüm veriler ele geçmiştir. Isıtma ve su sağlama gibi teknik sorunlar da yanıtlarını bulmuştur. Elde edilen buluntular ve gözlemlenen yapısal özellikler nedeniyle en erken İ.S. 2. yy.'da yapılmış olduğu ve 3.- 4. yy.'larda da onarımlar gördüğü düşünülmektedir. Yapı Roma içinde evrelere sahip olduğu gibi, Bizans Dönemi'nde de yoğun olarak konut gibi başka fonksiyonlarda kullanılmış ve revizyonlara uğramıştır. Hamam genel planlamasıyla Anadolu hamam-gymnasiumları karakteristiğindedir. 998 m²'lik toplam alanın yarısından fazlası palaestraya ayrılmıştır. Hamam bölümü düzenlemesinde genelde Likya'da yaygınca görülen alışlagelmış tasarım söz konusudur. Ana bölümler olan apoditerium, frigidarium, tepidarium ve kaldarium dikdörtgen planlarıyla aynı aks üzerinde yan yana dizilidir.

Bathhouse (Fig. 4): *The work at the bathhouse was undertaken by four teams and the excavations of the kaldarium, tepidarium, frigidarium, service and vestibulum parts were completed, while those in the palaestra resting upon four cisterns has been in part left to the 2007 campaign. All the architectural and interior*

furnishing evidence to be expected from a Roman bathhouse was uncovered. Technical questions regarding the heating system and water supply have also been answered. Evidence gathered and observations made point to a construction date in the 2nd century at the earliest, with repairs undertaken in the 3rd and 4th centuries. In addition to the sub-phases during the Roman period, the structure was restored and extensively altered and was employed for housing during the Byzantine period. The bathhouse overall is of the Anatolian baths-gymnasium type layout. It covers a total area of 998 sq.m., more than half of which was reserved for the palaestra. The baths section repeats the conventional layout often encountered in Lycia. The main sections of apodyterium, frigidarium, tepidarium and caldarium are aligned one after the other along the same axis.

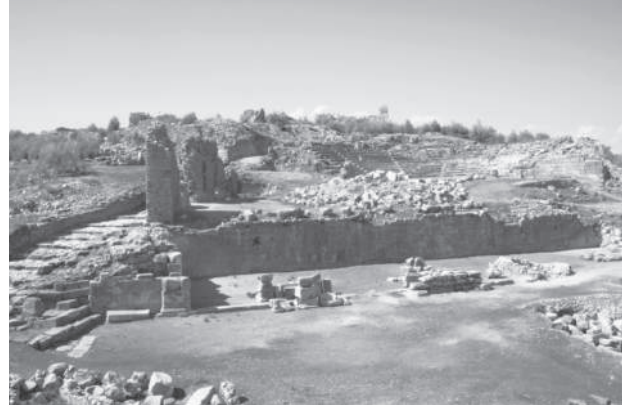
Res. 5 Rhodiapolis. Agora-Stoa. Kamu merkezi

Fig. 5 Rhodiapolis. Agora-Stoa. Public centre

Agora/Stoa (Res. 5 kazı öncesi için Res. 2): Kentin kamu merkezinde agora ve stoa birlikte organize edilmiştir. Stoa, agoranın batısı boyunca uzayan kapalı bölümü gibidir. Toplam 59 m. uzunluğunun 40 m.'si tamamen ve kalan kısmı üst katmanda kazılmıştır. Tüm alanın genişliği güneyde 29.90 m., kuzeyde 19.15 m.'dir. Bunun 9.20 m. genişliğindeki batı yarısı stoadır. Güney kesimde, her biri 7.40x11.25 m. olan 4 büyük sarnıç geniş terasın alt yapısını oluşturur. Agoranın iki tarafından da giriş vardır. Agoranın güney bitimi, sebasteionun kuzey yanı arasında kalan üçgen alan bir kavşak gibidir. Burada kentin doğu aşağısından çıkan yol agoraya, kentin batı girişine ve tiyatro-akropol sokağına yönelir. Aynı alandan düzayak agoraya girilirken, kavşaktan yükselen geniş basamaklarla da stoa'nın üst katına ve dolayısıyla Opramoas alanına geçit verir.

Agora/Stoa (Fig. 5, before the excavation see Fig. 2): In the public city centre, the agora and the stoa were organised together. The stoa almost constitutes the covered part of the agora to its west. 40 m. of the 59 m. total length were excavated entirely and of the remaining part, only the uppermost level was excavated. The entire area measures 29.90 m. wide on the south and 19.15 m. on the north. The 9.20 m. wide western half of this area is the stoa. In the south, four large cisterns, each measuring 7.40x11.25 m., constitute the substructure of the large terrace. The agora is accessed from two sides. The agora terminates in the south in a triangular junction-like area bordered on the north side by the sebasteion. Here, the road coming from the eastern lower part of the city turns toward the agora, the west city gate and the theatre-acropolis street. This area provided access to the agora at the same level while wide stairs lead to the upper floor of the stoa, and thus to the Opramoas square.

excavated areas and the diameters of the columns are ca. 43 cm. The columns are spaced 1.40-1.50 m. apart. In the middle of the stoa, it was understood from the fallen blocks that there was a two-storeyed stoa here. The remains indicate Doric columns rested on the stylobate without bases, supporting a plain architrave of three fasciae on the ground floor level, while the postaments of the upper floor correspond to the columns of the lower storey and supported Corinthian columns and the roof. A lime kiln was found in the middle of the agora. All the marble pieces from the area around the kiln had been burnt; further away from the kiln the number of architectural finds increased. The floor of the stoa was paved with mosaics along 60 m. Trial trenches opened in places revealed mosaics of three colours and geometric motifs that are quite well-preserved.

Excavations in the street (Fig. 5, before the excavation see Fig. 2): *The street network of the city can be traced mainly from the surface, evaluating the relations between the structures and the topography. The main road coming from Kumluca and Korydalla on the south reaches the southeast of the bathhouse on the skirt of the settlement hill and then ascends to the city. The road continues westward up the slope to the centre of the city. The street passes north of the bathhouse and ascends to the residential quarters of the city. The road extending westward up the slope to the city branches off into the settlement. Most of these streets can be easily traced. The road leading to the city centre reaches the agora platform as a narrow street parallel to the front of the sebasteion (north) and becomes the junction of a network extending to various parts of the settlement. The street leading north from the junction reaches the agora-stoa, the one to the west reaches the west gate and the one to the northwest reaches the acropolis and the theatre. The street turning toward the agora also ascends in steps to the upper floor of the Opramoas stoa. The 43 m. long street extending from the junction before the sebasteion to the eastern analemma of the theatre is 5.10*

m. at its widest point. It is entirely paved with stones and has steps. At the beginning of the street are the stairs turning north to provide access to the upper floor of the stoa. Eight of the steps leading to the Opramoas stoa are preserved and indeed there must have been 10 in total but the top two steps were destroyed together with the monumental entranceway. Starting from the bottom of the street, these stairs in a north-south direction are 3.60 m. wide.

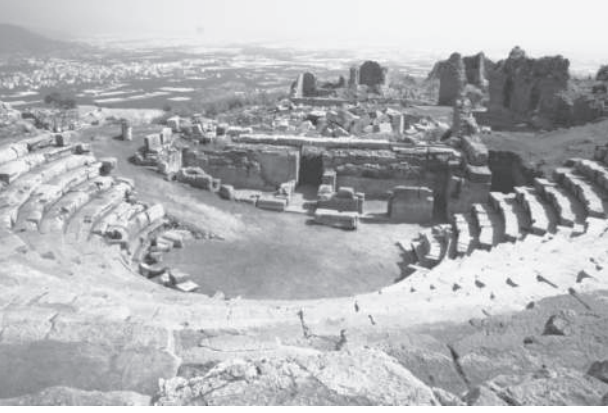
Res. 6 Rhodiapolis. Tiyatro

Fig. 6 Rhodiapolis. Theatre

Tiyatro (Res. 6): Kazısı yaklaşık %80 oranında tamamlanmıştır. Neredeyse tamamen örtülü ve dolu bulunan kavea, orkestra ve proskene tamamen açılmış sadece sahne binasının arka kesimi ile paradosların bir kısmı kalmıştır. Sahne binasının bırakılma nedeni Opramoas anıtı ile iç içe olması ve ikisinin birlikte ele alınmak zorunda oluşlarıdır. Tiyatronun kazıları 2007 sezonunda tamamlanmış olacaktır.

Theatre (Fig. 6): 80% of the theatre's excavation has been completed. The cavea, orchestra and proskene, which were almost entirely buried, were exposed while the rear of the stage building and parts of the parodoi were not entirely exposed. The stage building was left this way because it forms a set with the Opramoas monument and they need to be excavated together. The excavation of the theatre will be completed in 2007.

Tiyatronun çapı 39.22 m.'dir. Kaveada 7 merdiven arasında 6 kuneus/kerkides bulunur. Tam yuvarlak olan orkestranın çapı 10.52 m.'dir. Kaveanın en üst noktasında sıralanan oturma koltuklarından orkestra düzlüğüne kadarki tiyatronun yüksekliği 9.24 m.'dir. 16 adet oturma sırasının ortalama yüksekliği 0.40 m.'dir. Oturma sıralarının genişliği 75-80 cm. arasında değişir. Bu genişliğin öndeki 37-38 cm.'lik kısmı oturmak için daha ince işçilikle üretilmiştir. Arkada aynı ölçülerdeki diğer yarısı ise ayak koymak içindir ve daha kaba işçiliktir. Kuneuslar arasındaki iniş-çıkış merdivenlerinden 4'ünde 33 basamak bulunur. 7 merdivenden 3'ü oturma sıralarından sonra orkestra korkuluklarının arasından da inerek orkestra düzlüğüne çıkıntı yapar. 38 basamaklı bu üç merdiven oturma sıraları bittiği yerden itibaren orkestraya yanlarında korkuluklarla ve silmeli işçilikleriyle ulaşır. Korkuluklu iniş bölümünün yüksekliği 1.30 m.'dir. Altlarında aslan ayakları eşit aralıklarla tüm orkestrayı çevreleyecek biçimde dizilidir. Oturma sıralarında bulunan ayaklardan farklı olarak üstlerinde hiçbir bezeme yoktur. Kaveanın ön 3 sırasında 8 adet kare formlu oyuklar bulunur. Belirli bir düzende değil, kendi içlerinde alan düzenleme gösteren dizilişleri vardır. Bu diziliş en altta orkestra çevre duvarının üstündeki geniş düzlemde yerleşik olan 9 kare oyukla birlikte bir anlam taşımaktadır. Anlaşılan kavea alt kesiminde direklerle oluşturulan bir parçalı çadır sistemi, asıl kaveanın çoğunluğunu örten kalın yuvarlak direklerin taşıdığı bir çadır sistemi vardır. Çadır sisteminin kavea arkasından nasıl desteklendiği konusunda sadece bir iz vardır. Kaveanın doğu

The cavea mainly sits on the hillside. The eastern one-third is formed by the analemma wall behind the first two cunei on the east and this section has the tallest and strongest wall of the theatre. The polygonal masonry walls have two rows of cut stone blocks – one 2.55 m. below the top and the second 2.08 m. further below. This displays Hellenistic features and the wall in this area is supported by four strong buttresses.

The diameter of the theatre is 39.22 m. and the cavea has 6 cunei/kerkides bordered by 7 stairs. The fully round orchestra has a diameter of 10.52 m. The cavea rises 9.24 m. above the orchestra. 16 rows of seats are each 0.40 m. tall. The depth of the rows of seats varies from 75 to 80 cm. The front 37-38 cm. of this depth is finer worked for sitting upon, while the rear half of the same width is more coarsely worked for the feet. Four sets of stairs between the cunei have 33 steps each. Three of the seven stairs protrude into the orchestra passing through the balustrades after the first row. These three stairs have 38 steps each and extend with balustrades and profiled workmanship from the first row into the orchestra with this extension rising 1.30 m. beneath which are lions feet at equal distances around the entire orchestra. These lion feet do not carry any decoration at all, differing from those decorating the rows of seats. The first three front rows of the cavea have 8 square holes, which are aligned within an area, not according to any certain rule. This alignment makes sense, when taken into consideration together with the 9 square holes on the encircling wall of the orchestra. As inferred, the lower part of the cavea was covered with a partitioned tent covering system and the majority of the cavea was covered with a tent system supported by thick round posts. There is only one trace regarding the supporting of the tent system from the back of the cavea, on the eastern end of the cavea, there is a hole for placing the supporting post in the analemma wall corresponding to the middle of the first cuneus. This

The upper part of the stage building extending in an east-west direction has entirely collapsed; only the ground floor has been preserved. The upper part of the proskene is also in ruins and extends at a tangent to the circle of the orchestra. The stage building is 7.94 m. wide including the proskene and 16.11 m. long. Five doors open on the proskene front. The stage building has two rectangular rooms inside. The vaults carry a stone slab pavement, preserved in the western corner of the proskene.
